Bureau Enquêtes Accidents pour la Sécurité de l'Aéronautique d'État (State Aviation Safety Investigation Bureau - BEA-É)

Safety Investigation Report

A-2021-09-A

Event date Place Type of aircraft Organization April 13th 2021 Cavaillon (Bouches-du-Rhône) Cirrus SR22 Armée de l'Air et de l'Espace (French Air and Space Force)

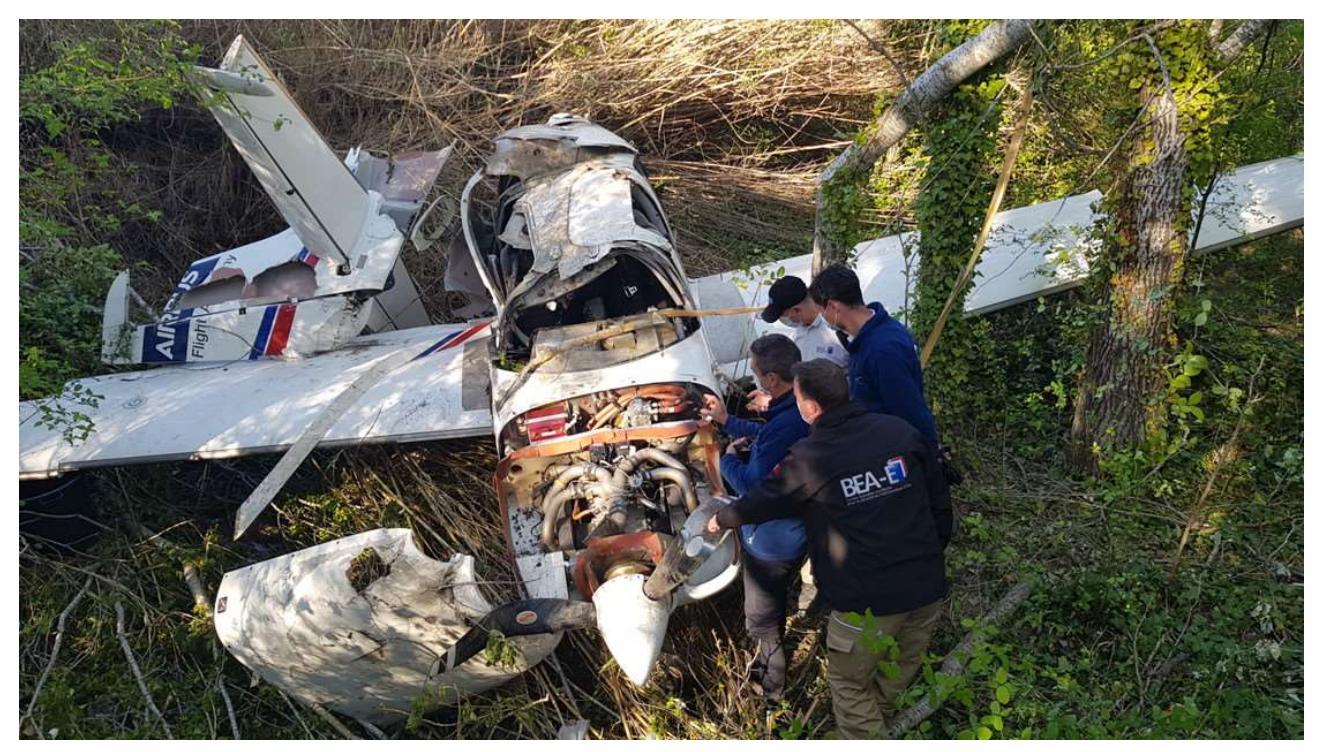
Figure 2: wreck of the Cirrus SR22

The aircraft was destroyed.

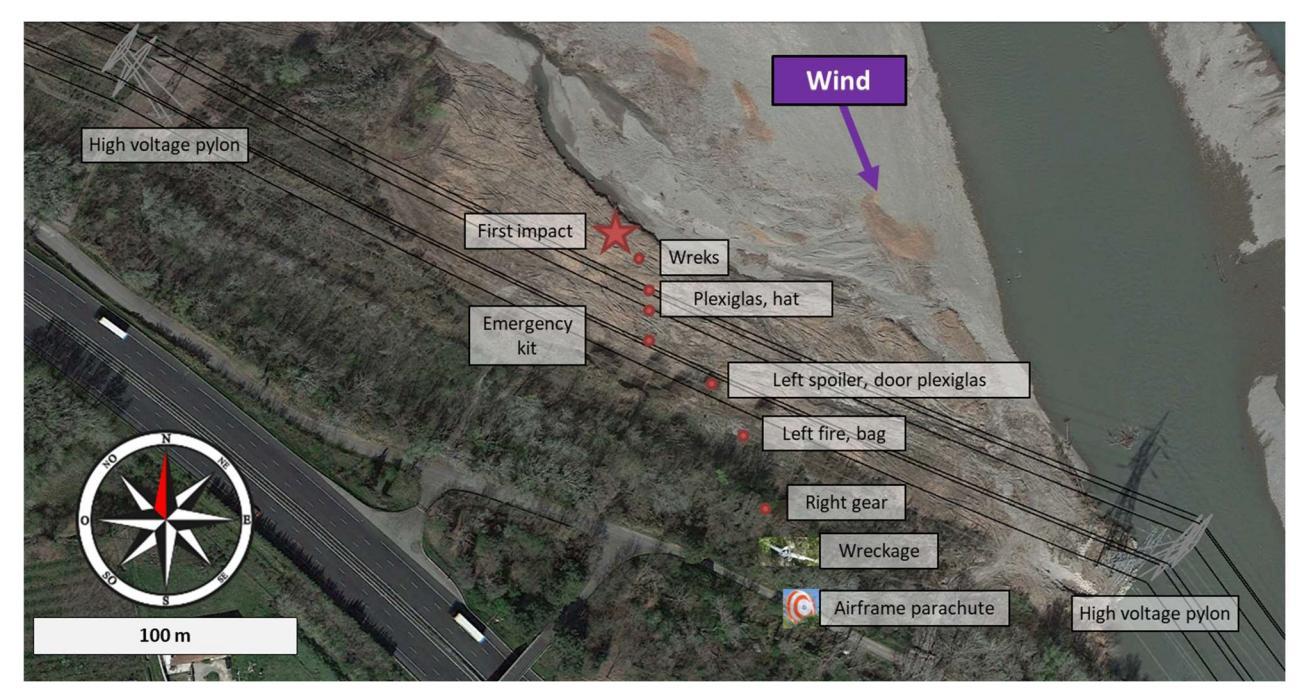
Figure 5: Identification of the wreckage

The aircraft first hit the bed of the Durance north of a high-voltage line. It was then dragged southwards by parachute acting as a sail in the wind over a distance of two hundred metres. Many marks and grooves were observed on the ground, tracing the passage of the airframe. The ground was littered with debris and remains of equipment along this route. These marks along the ground confirm that the aircraft passed underneath the high-voltage line, which is confirmed by an eyewitness who was present at the bottom of the electricity pylon to the south-east of the initial point of impact.

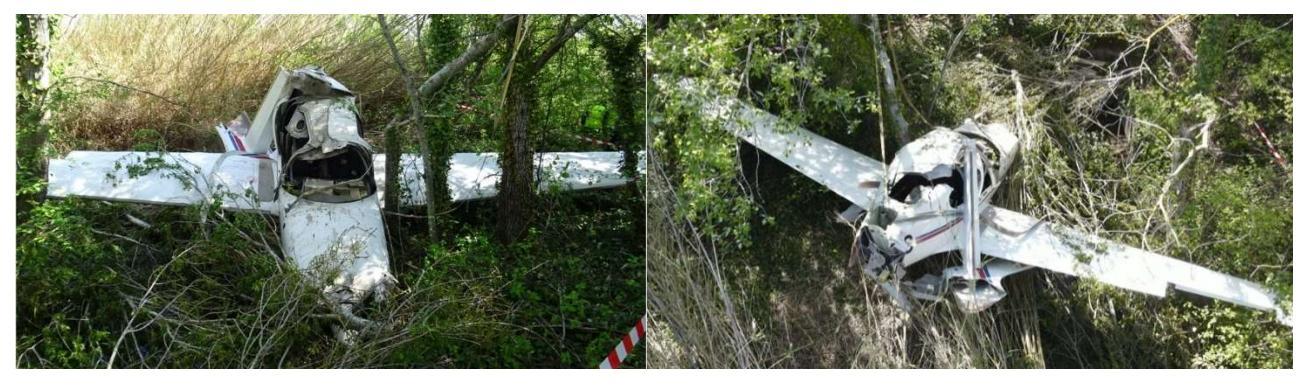
Figure 6: Wreck viewed from the front and above

The aircraft was destroyed while being dragged along the ground by the parachute. It was stopped by the trees and ended almost hanging above a pond.

The aircraft was almost horizontal and on its underside. The upper part of the aircraft was crushed, and the rudder was completely twisted and broken.

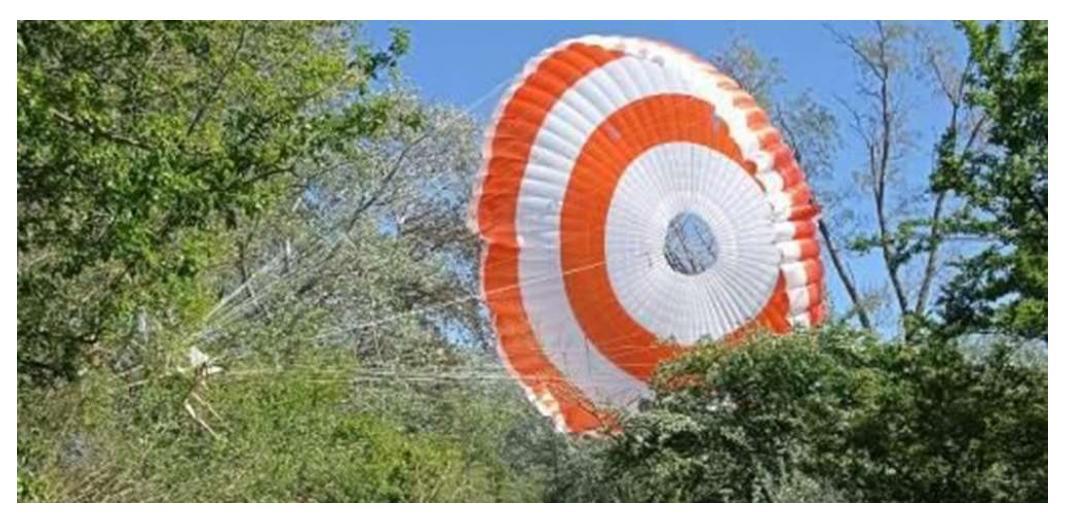
Figure 7: airframe parachute still billowing in the wind on the arrival of the emergency services

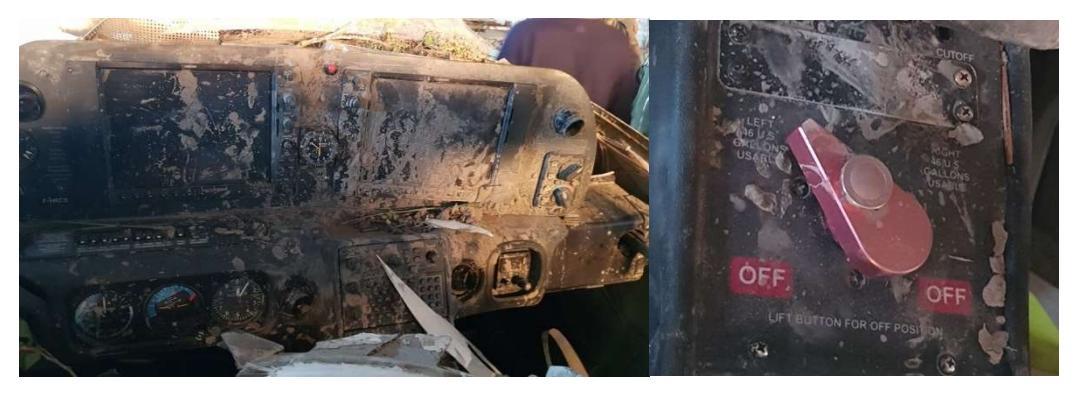
Figure 8: instrument panel Figure 9: Fuel selector

A significant amount of mud was found in the aircraft cockpit. All the windows were broken, and several pieces of plexiglass were strewn inside the aircraft. The fuel selector was in the "left tank" position.

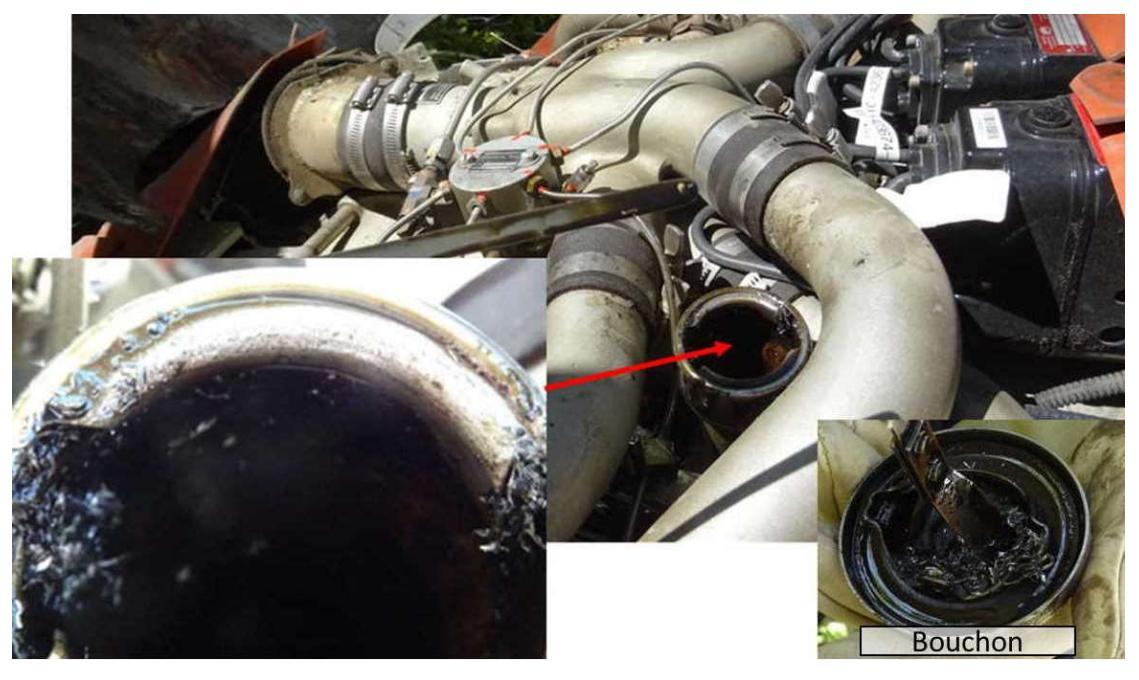
Figure 10: engine (large quantity of filings at the filler cap)

On-site examination of the Continental engine of the aircraft revealed a large quantity of metal filings in the area oil filler cap. Pistons Nos. 1 and 2 were jammed.

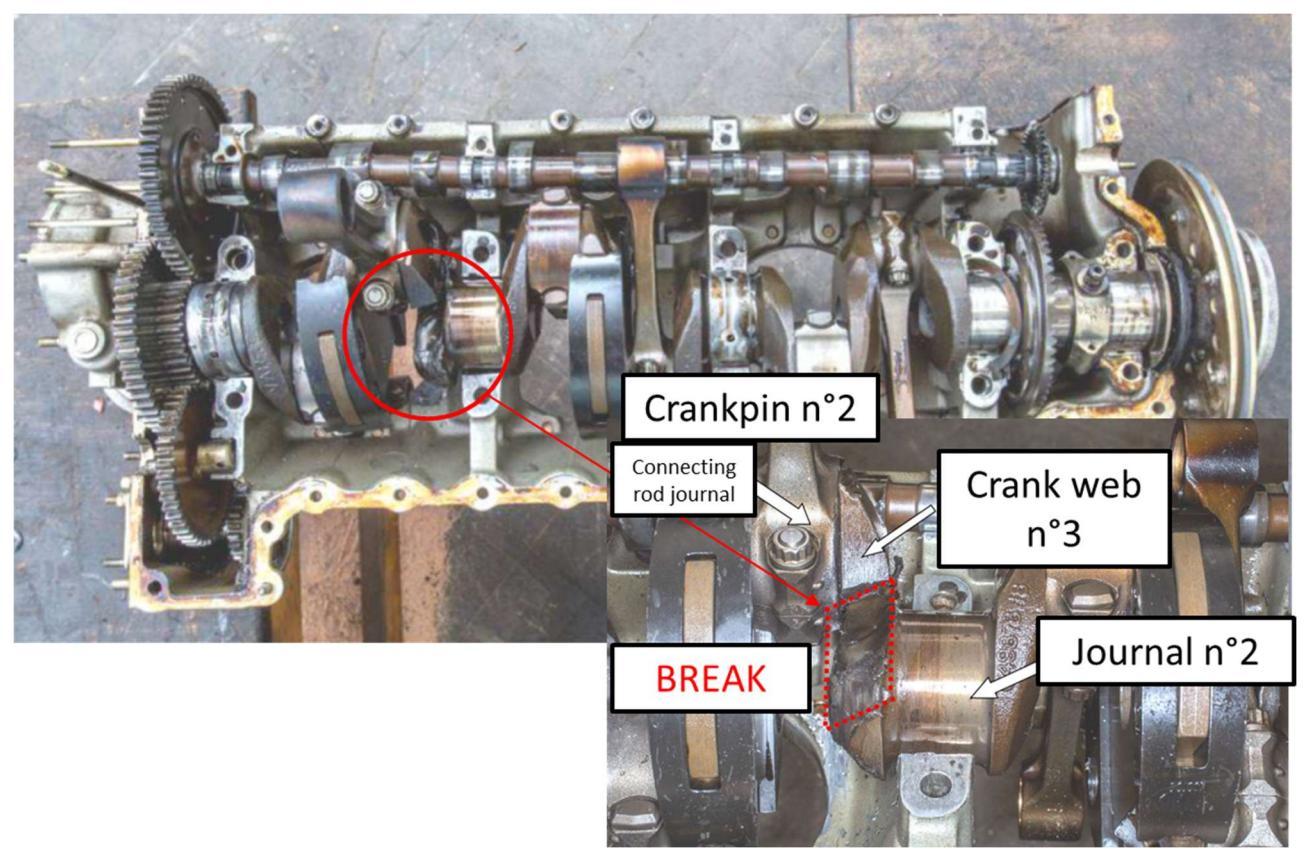
Figure 13: Engine open after removing the casing

While dismantling and inspecting the engine in the workshop, the following principal damage was identified:

- broken crankshaft at web No. 3;
- overheating traces on the surface of journal No. 2;
- destruction of bearing shell No. 2;
- significant wear of bearing No.1.

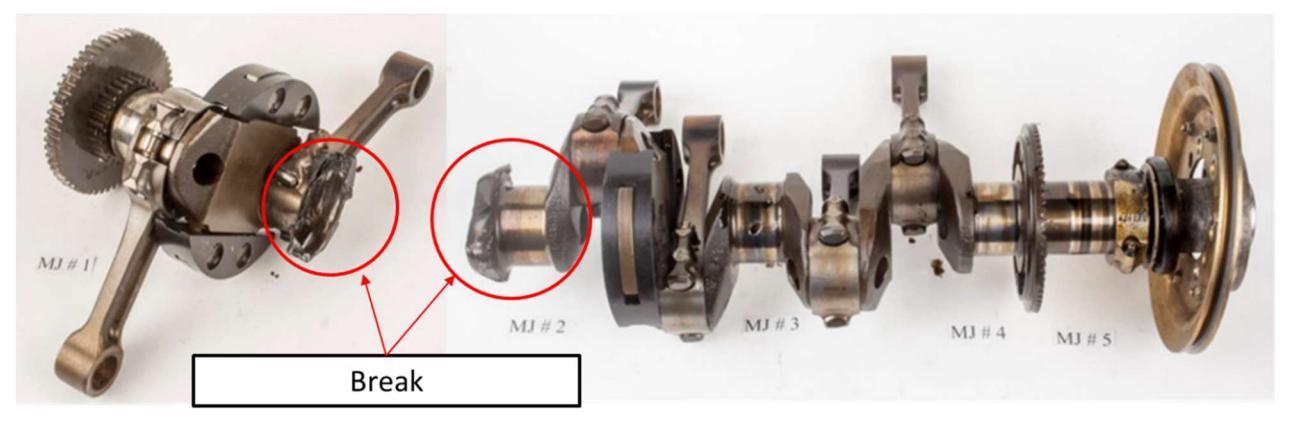
On dismantling the crankcase, the rupture of web No. 3 of the crankshaft was clearly visible. This break is located in the fillet of the web close to journal No. 2. The limited damage in the surrounding areas of the engine seems to indicate that the crankshaft was subject to moderate load at the moment of failure. It is a sign that the engine was operating normally.

Figure 15: Crankshaft broken

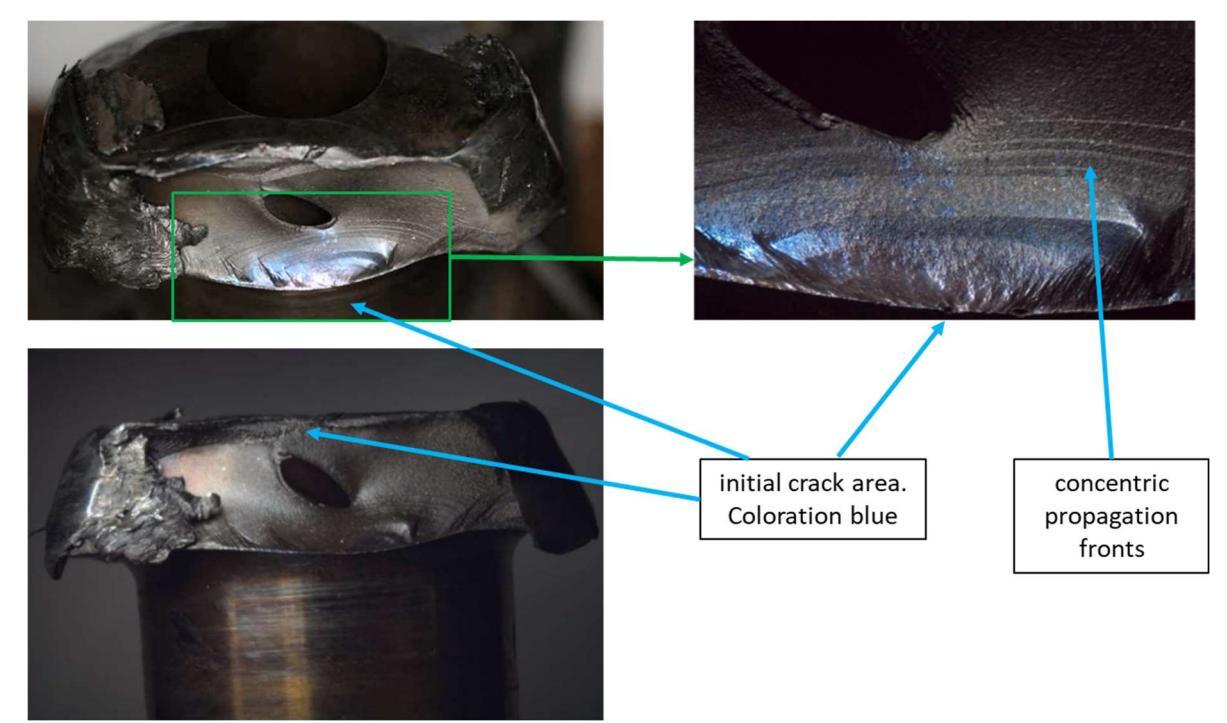
Several concentric propagation fronts towards the initial area indicate final failure due to propagation of a fatigue crack. Blue colouration, a sign of local overheating, is visible only in the area of the failure.

Figure 17: Trace of overheating at journal No. 2

Blue colourations are distinctive indicators of a significant increase in temperature. This colouration is only visible over a part of journal No. 2 and not over the entire area.

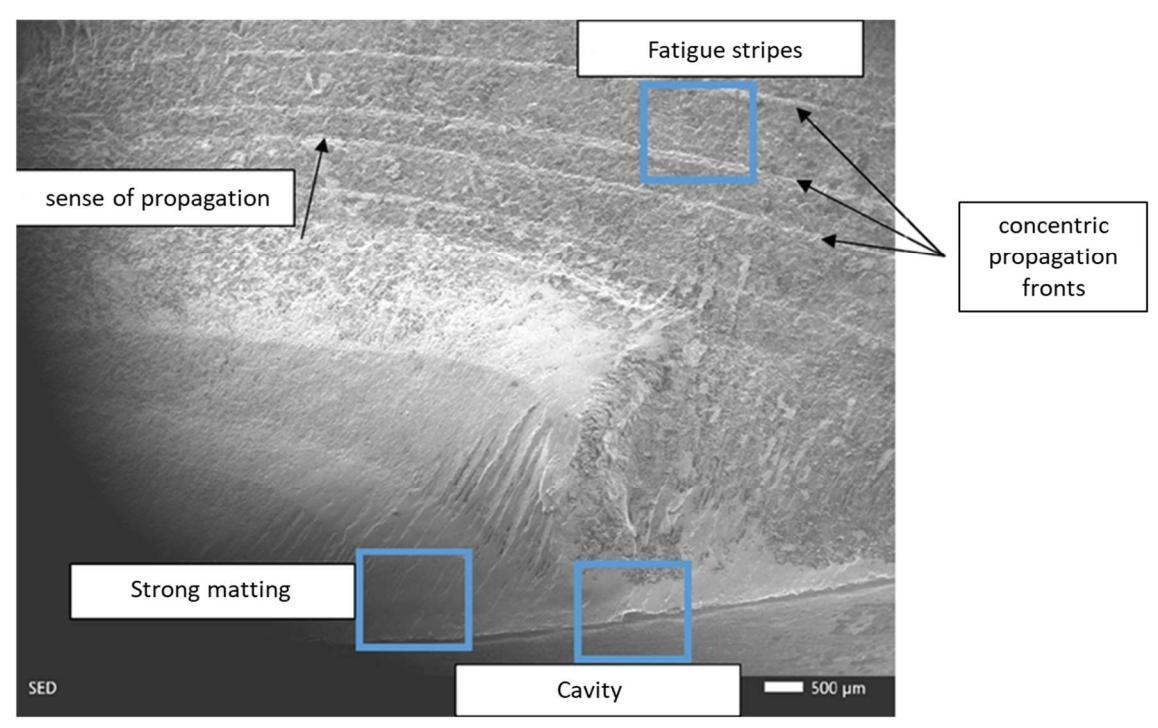
Figure 18: View of the break under scanning microscope

Observation by scanning electron microscope revealed darkening of the initial crack area. The original appearance is therefore no longer observable. The crankshaft rupture was probably due to local overheating that started fatigue cracking of the fillet of web No. 3 and journal No. 2.

The stalling of the engine was a direct consequence of the rupture of web No. 3 of the crankshaft, following fatigue cracking that was probably caused by local overheating.

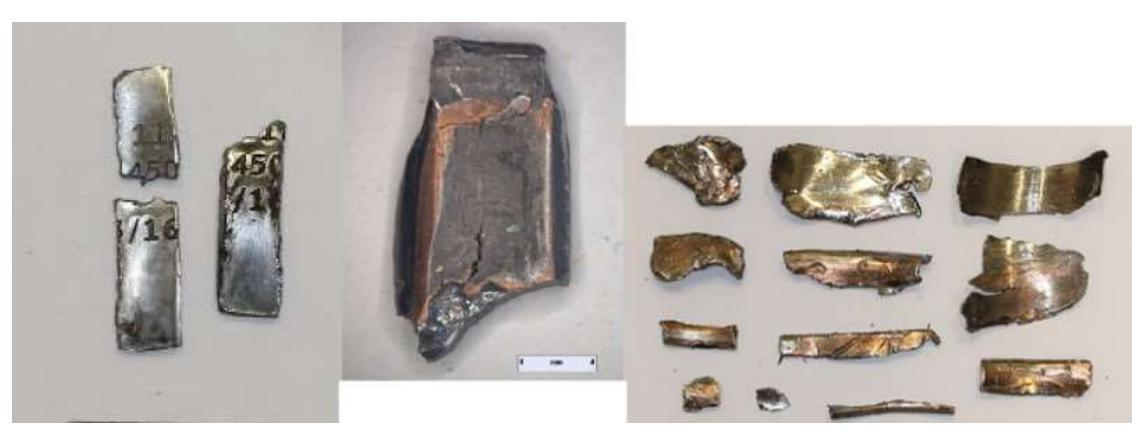
Figure 19: Fragments of the shells of bearing n° 2

The shells of bearing No. 2 were totally destroyed by the accident. Fourteen fragments of bearing No. 2 were found at the bottom of the crankcase, and the crankcase support is significantly hollowed. Only some fragments were analysed. The shells of bearings Nos. 1, 3, 4 and 5 were also analysed.

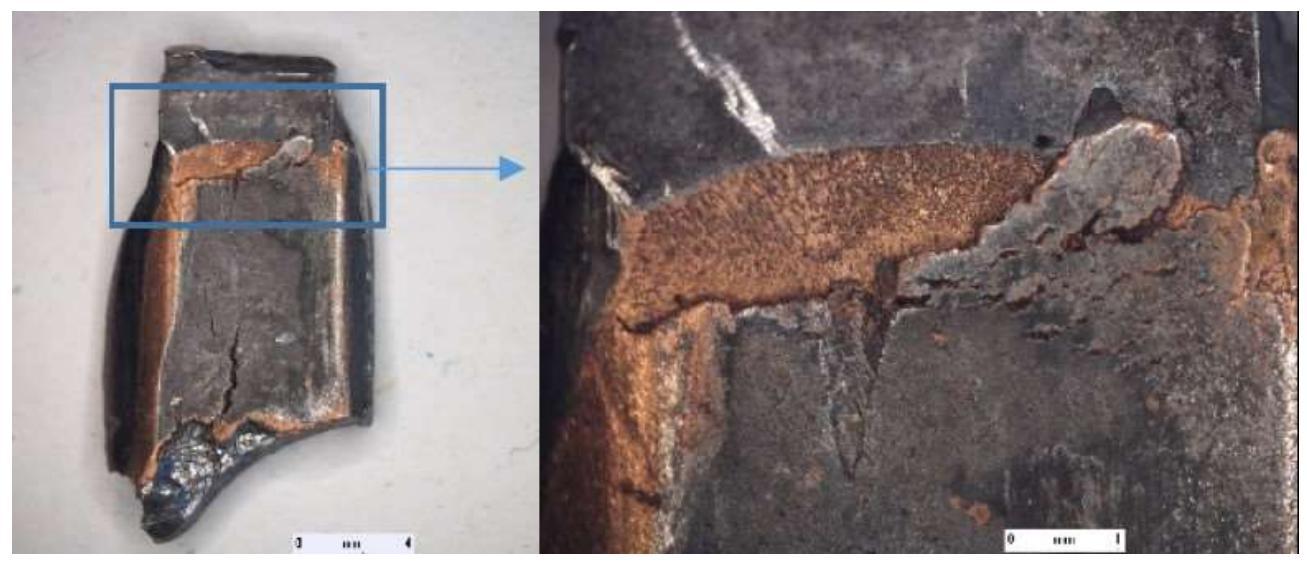
Figure 20: Fragments of shell of bearing No. 2 under binocular microscope

Binocular observation of a fragment of bearing No.2 shows the presence of several layers. A grey upper layer is on top of a copper-coloured layer. However, the anti-friction coating has almost disappeared in the fragments of bearing No. 2. The fracture surfaces of the fragments of bearing No. 2 were unusable for further detailed analysis.

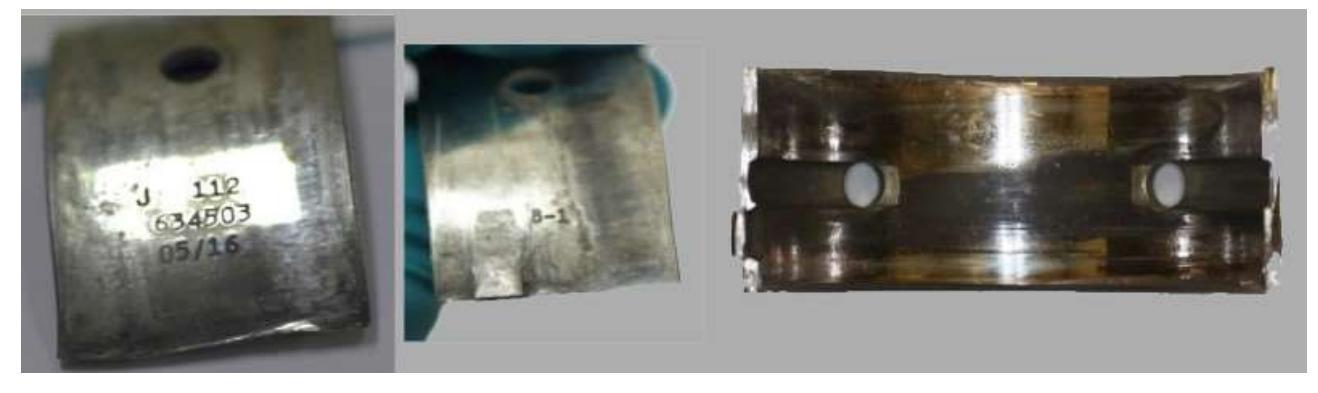
Traces of operating friction can be seen on the anti-friction coating of bearings Nos. 1, 3, 4 and 5. Bearing No. 3 is the bearing of the most severe marking. It is considerably worn. In the figure above, it can be seen that the copper colour of the anti-friction coating is separated by a greyish band in the centre. The anti-friction layer seems to have been gummed.

The engine stalled immediately on rupture of the crankshaft. On comparing the condition of bearing No. 2 with the other bearings, the destruction of the shells of No.2 and the hollowing out of their supper cannot be exclusively the result of the engine failure. Bearing No. 1, which was exposed to stresses close to its breaking point, remained almost intact, with a slight wearing of the anti-friction coat without any major loss of material. In conclusion, the deterioration of the shells of bearing No. 2 had occurred before the crankshaft broke.

Bearing No. 2 was damaged before the accident occurred.
