Bureau Enquêtes Accidents pour la Sécurité de l'Aéronautique d'État (State Aviation Safety Investigation Bureau - BEA-É)

Safety Investigation Report

A-2021-09-A

Event date Place Type of aircraft Organization April 13th 2021 Cavaillon (Bouches-du-Rhône) Cirrus SR22 Armée de l'Air et de l'Espace (French Air and Space Force)

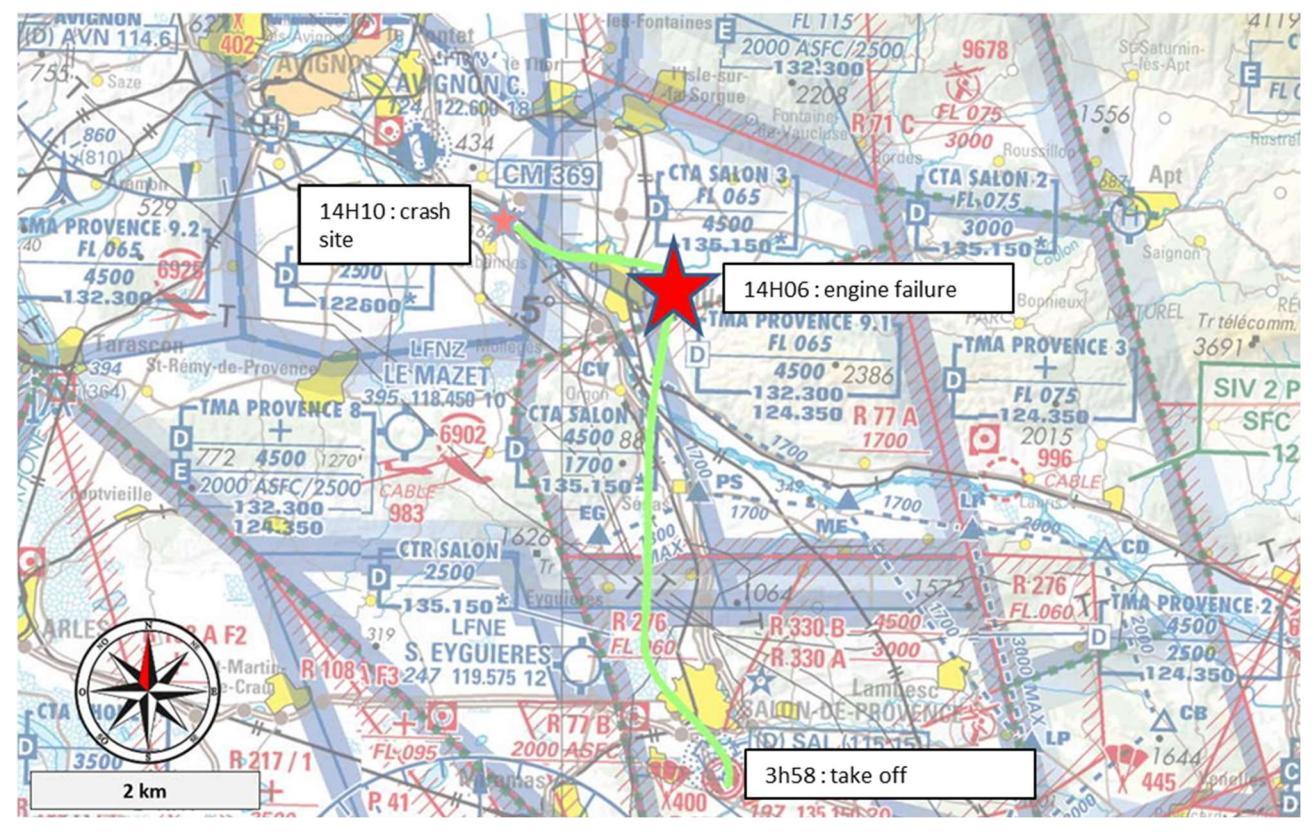
Figure 1: Aircraft's flight path

He set the transponder to 7 700 and sent a distress message. The pilot then announced to Marseille-Provence air traffic control that he would head to Avignon airport. Flying at a speed of 105 kt with flight path heading north-west, the aircraft rapidly lost altitude. Since the wind was now blowing from the north at 35 kt, the crew realized that they would not be able to land at Avignon airport. With no further option of landing to any accessible runway, the pilot attempted to restart the engine. The propeller then, came to a complete and permanent stop. Finally, the pilot steered the aircraft towards the Durance River. Since he had not identified a suitable terrain for an emergency landing, the pilot, with the approval of the PIC, positioned the aircraft above the bed of the Durance and got the aircraft ready for the use of the airframe parachute system. However, he sighted a high-voltage power line below the aircraft, between the Durance and the motorway. So, he deferred the parachute ejection procedure and had to release it at the limit of the operating range of the Cirrus Airframe Parachute System (CAPS). Finally, at an altitude of 600 ft, he raised the nose of the Cirrus to reduce the speed of less than 100 kt and actuated the CAPS. A short time after this operation, the aircraft hit the ground. The airframe was immediately overturned by the gusts that continued to fill the canopy of the parachute like a sail, and the aircraft was dragged upside down along on the ground for two hundred metres. The crew took advantage of a few seconds of calmer winds, during which the aircraft stopped moving, to evacuate the cabin in two stages. The aircraft finally came to a complete stop in a grove of trees close to the motorway. It was totally destroyed, and one member of the crew was slightly injured.

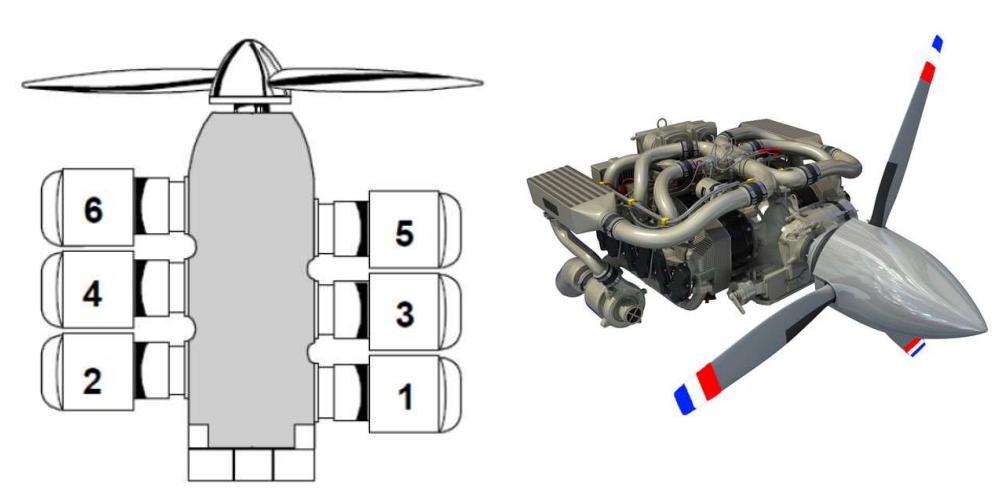
Figure 12: flat six-engine

The Continental IO-550 engine is a large family of fuel injected six cylinder, horizontally opposed, air-cooled aircraft engines that were developed for use in light aircraft by Teledyne Continental Motors. The first inspections at the crash site noted that some pistons had seized.

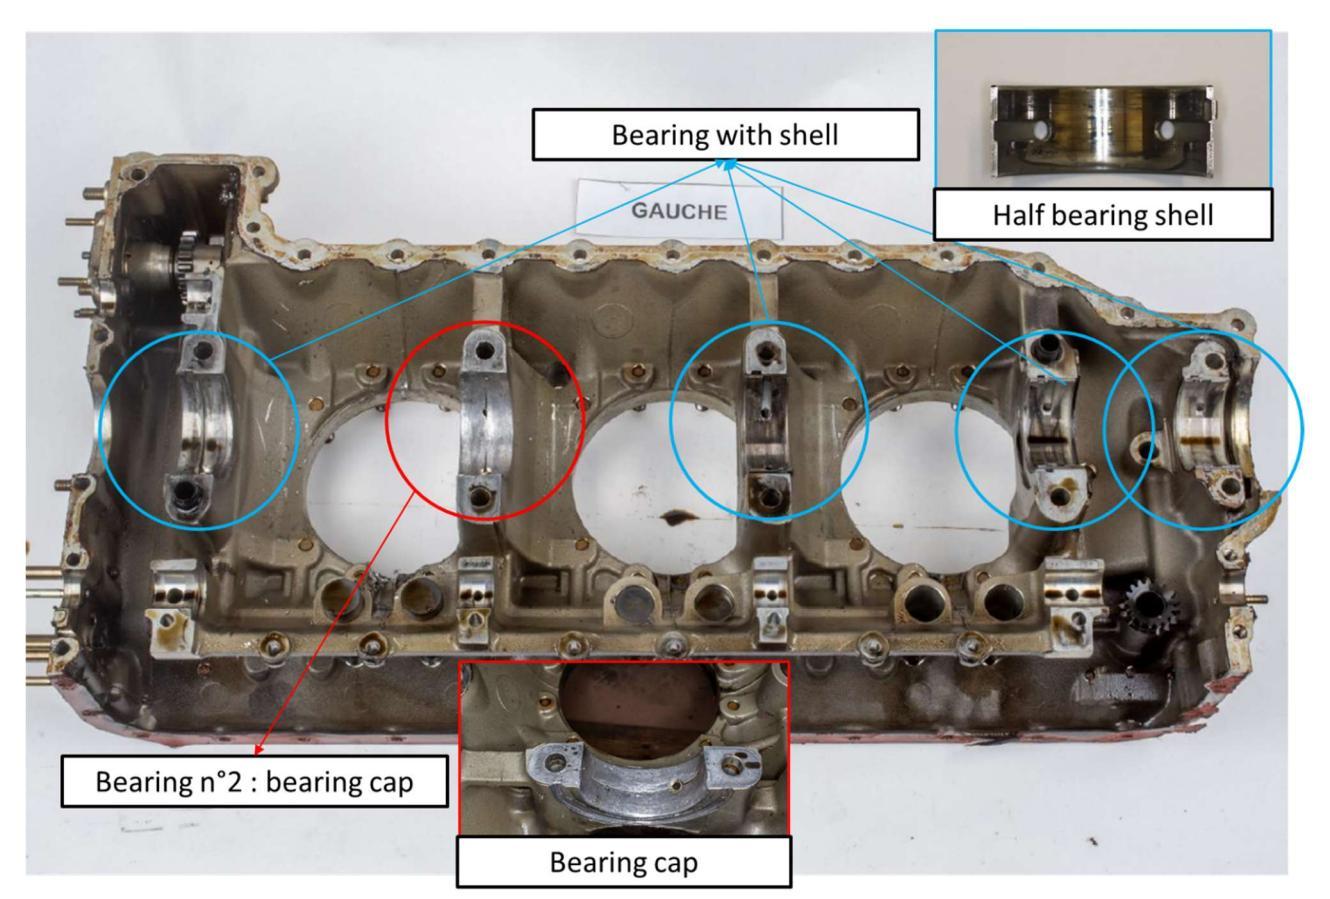
Figure 16: Left half of crankcase open

Bearing shells are smooth bearings which are in direct contact with rotating shafts. Smooth running is ensured by the materials chosen and by a film of oil. On this engine, the bearings consist of two steel half-shells housed in their respective caps (Figure No. 16). Their bearing surface is coated with different layers of lead/tin/copper alloy. Their surface also has small grooves that - due to the speed of rotation - enable oil to be retained.

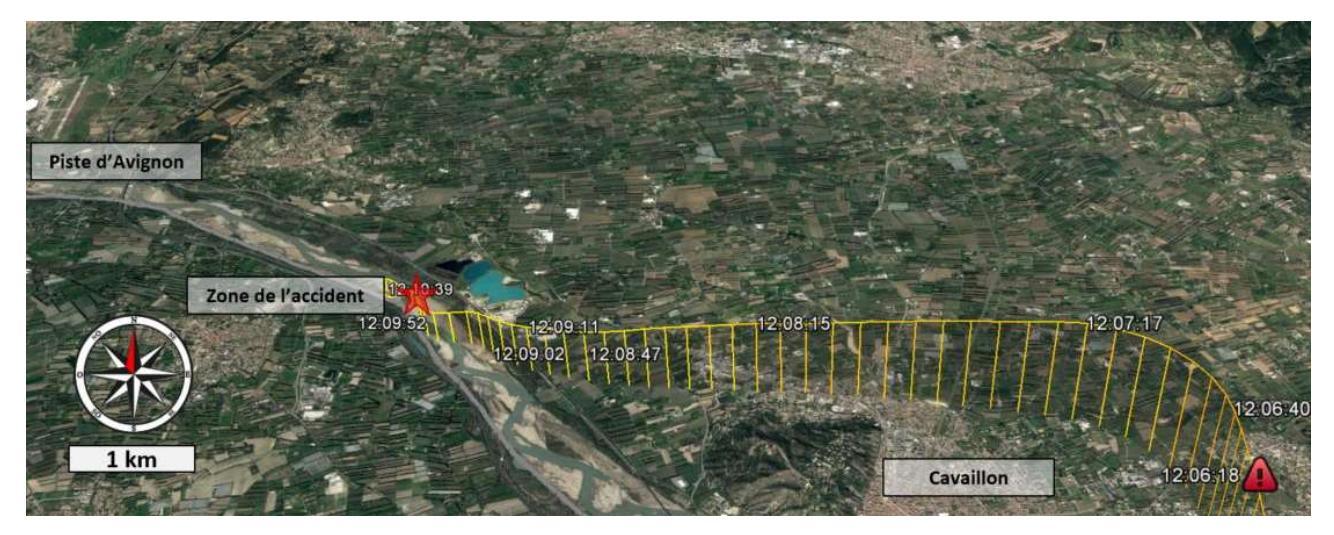
Figure 22: End of the flight path

The sequence of the accident could have been replayed with the data of the flight data recorder, the testimony of the crew and with the audio recording of the Provence air traffic control.

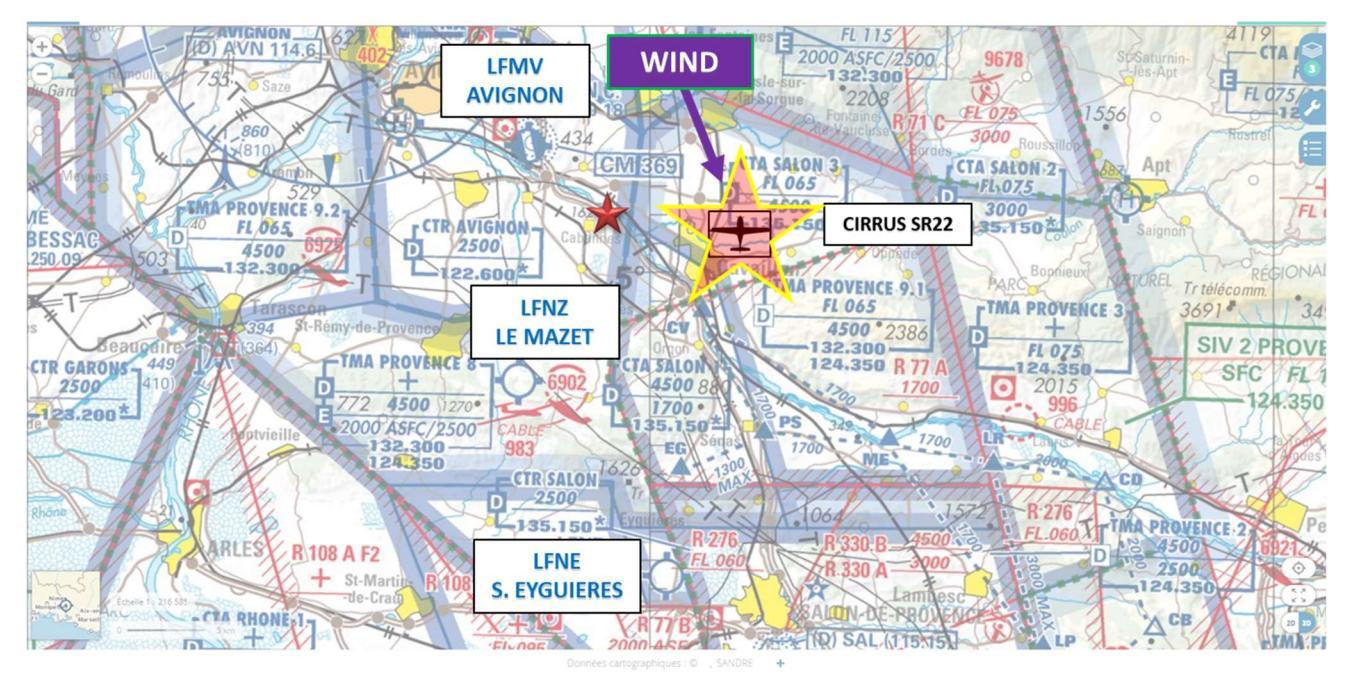
Figure 25: Context at the time of engine failure

The choice of Avignon airfield seemed obvious to the crew, and the pilot persisted with this decision for two minutes. The engine failure occurred while the crew was at an altitude of 5 400 ft above Cavaillon.

25 seconds after the engine failure occurred, the time taken to analyse the situation and carry out the first reflex actions, the pilot decided to divert the aircraft to Avignon airport, and aircraft descended below 5 000 ft. The weather conditions at that moment were not favourable to reaching Avignon. A wind was blowing from 340° with a speed of 26 kt and gusts of up to 40 kt at 5 000 ft. Avignon airfield (LFMV) was located at a distance of 8 Nm with a heading of 300°. In the opposite direction, Eyguieres airfield(LFNE) was 11 Nm away with a heading of 195°. However, the presence of the Alpilles low mountain range on this flight path mode this runway inaccessible by gliding. Finally, even the airfield of Mazet de Romanin (LFNZ) at 8.5 Nm, with a route perpendicular to the wind, was also inaccessible for a glide approach. Moreover, this airfield is not asphalted, and the personnel at CFAMI never considered it to be a possible solution because of its proximity to the Alpilles. However, the configuration of the area is favourable to an off-airport emergency landing, with the availability of several clear fields.

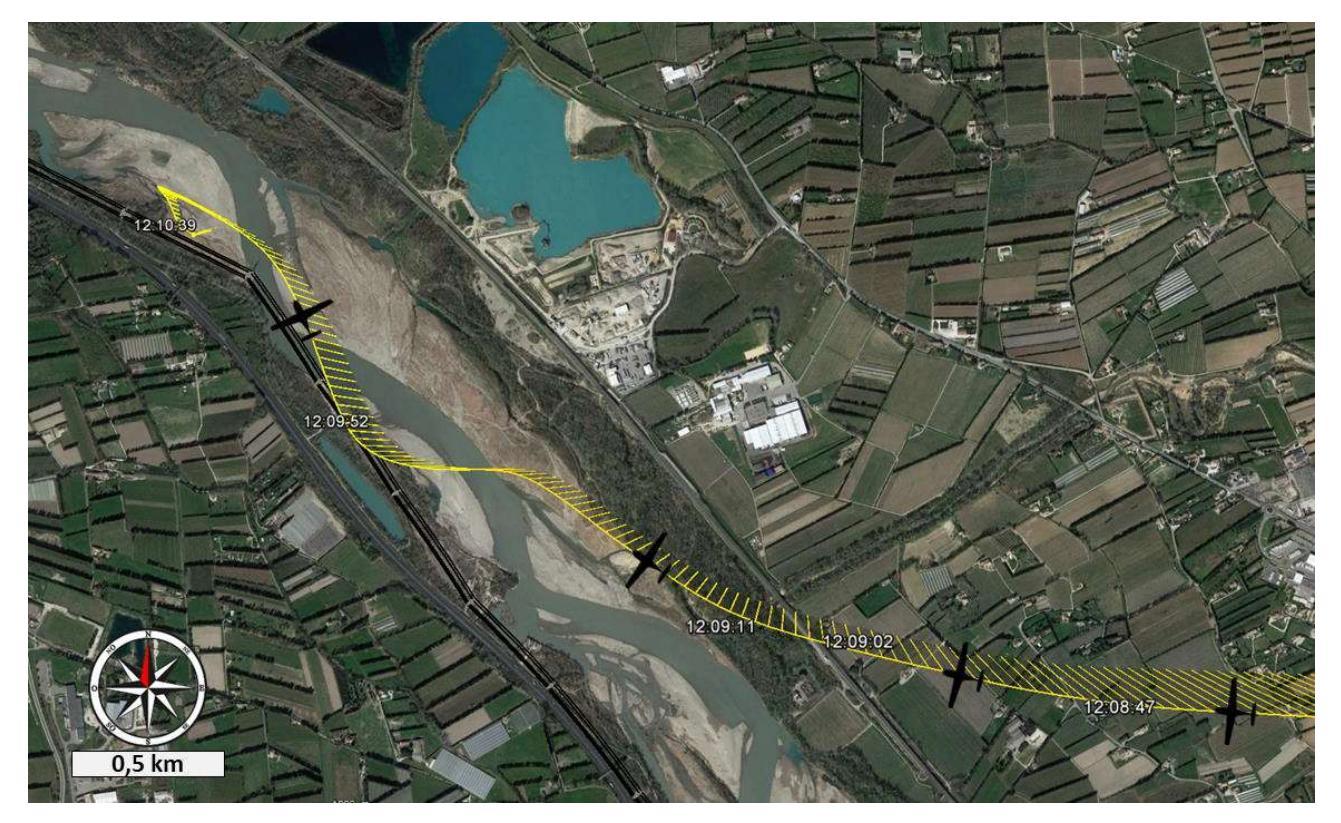
Figure 26: Last few minutes of glide path

With an emergency landing now entirely out of the question, the pilot prepared to deploy the airframe parachute. However, a short time earlier, focusing on the search for a suitable terrain, the crew had forgotten the presence of a high-voltage line, which was now directly below the aircraft.

The crew's decision to change its initial plan was late. For two minutes, they continued trying to land at Avignon. They decided to give up this attempt when the aircraft had just reached the minimum deployment limit of the CAPS and was flying over an area that was unsuitable for emergency landing or for the deployment of the airframe parachute.
